Manhole Inspection Summary

Manhole # S35CC1003MH

Insp Date: **12/7/06 9:57 AM**

Location Address: **3701 CHANCERY RD**

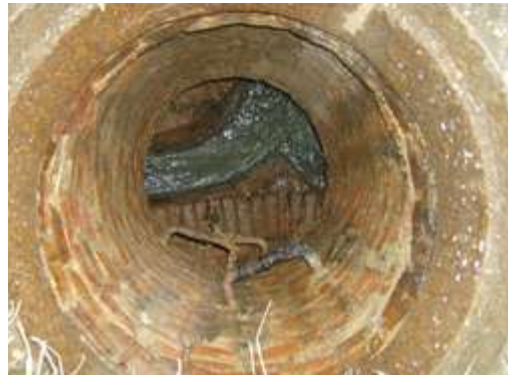
Top View

Bench ☒ Exists Material: **Brick** ☐ Parged ☒ **Debris** (not Condition related)

Steps Count: **3** Missing: **0** ☒ **Corroded**

Surcharge ☒ **Evidence Of Surcharge** Depth: **1.5** (ft.) ☐ Active Surcharge Present

Corroded steps. Evidence of surcharge - Bench debris.

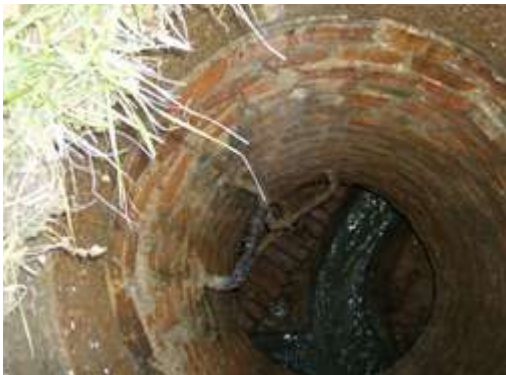
Defect

Condition: ☐ Sound ☐ Cracked ☐ Root Intrusion ☐ Loose Brick ☒ **Deteriorated**

Infiltration: ☐ None ☒ **Joint** ☐ Cracks ☐ Mortar ☐ Roots ☒ **Wall**

Adjustment deterioration and infiltration.

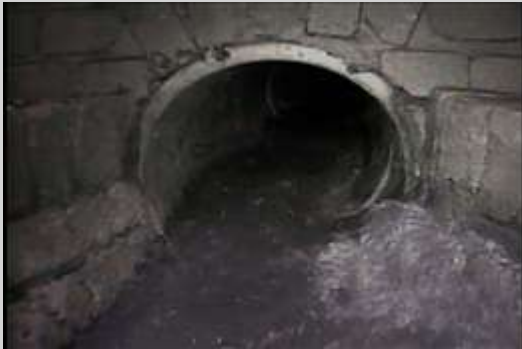
12 in. Circular Gravity Sewer Pipe Out @ 12 O'Clock

Infiltration: **Evidence** Pipe Seal Cond: **Unknown**

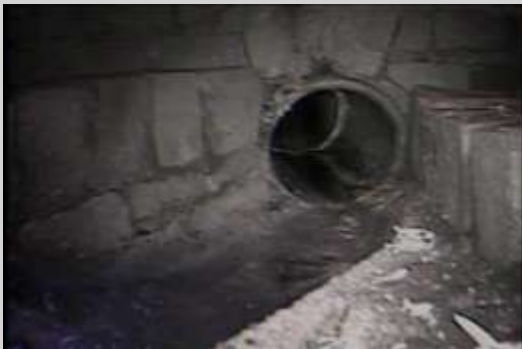
6 in. Circular Gravity Sewer Pipe In @ 4 O'Clock

Infiltration: **Evidence** Pipe Seal Cond: **Unknown**

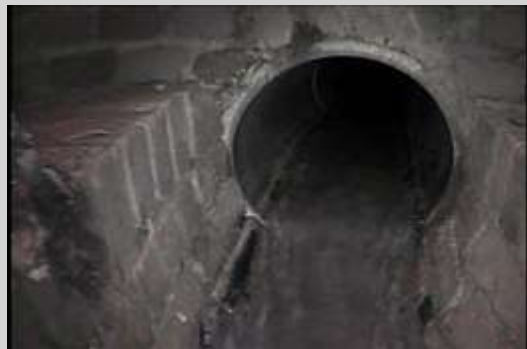
Pipe In @ 7 O'Clock

Infiltration: **Evidence**
